Service Report (3)

DB Location	Office
DB Name	Office db
Number of RCD per board	2
SWB neatly Labelled or is there a DB Legend?	No
Is the Insulated Busbar in good condition?	NA
Are there any Missing Pole Fillers?	No
Missing Screws?	No
Wiring Condition?	Fair
Are there any Holes / Penetrations on the board?	No
Are electrical circuits RCD protected?	Yes
Are there Recalled RCD's Installed?	Yes
Thermal Status	Pass

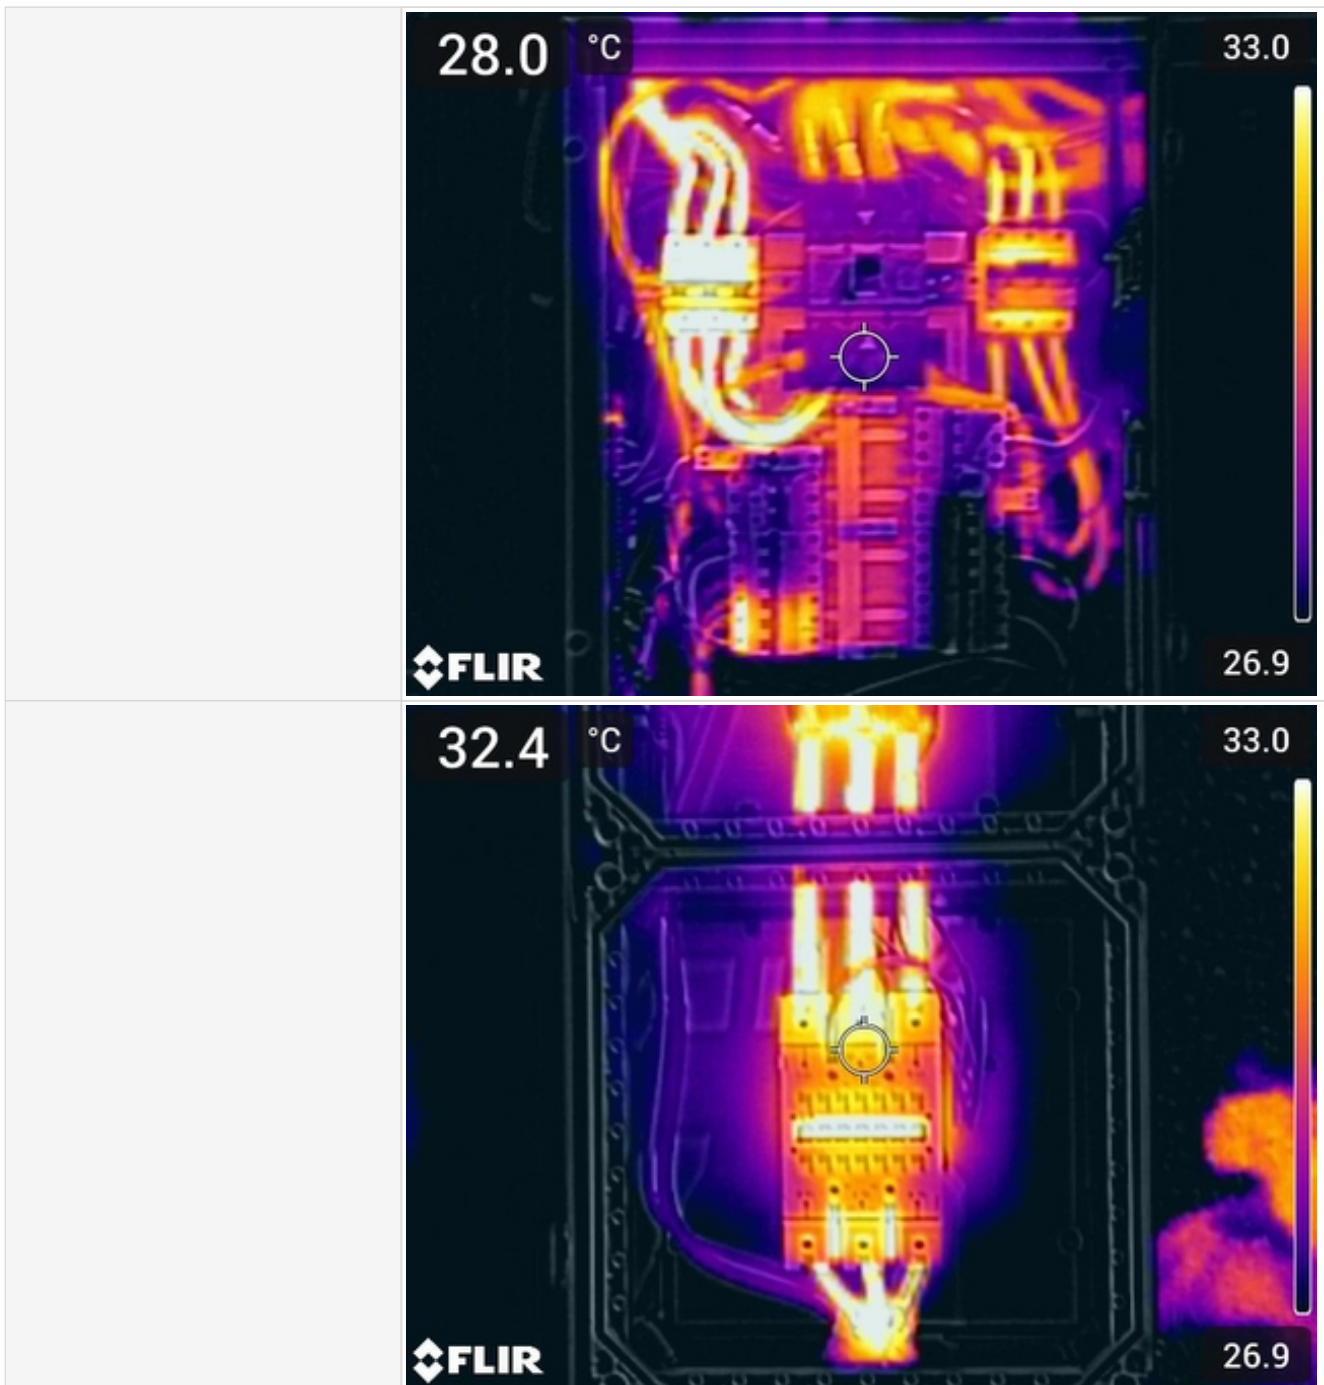
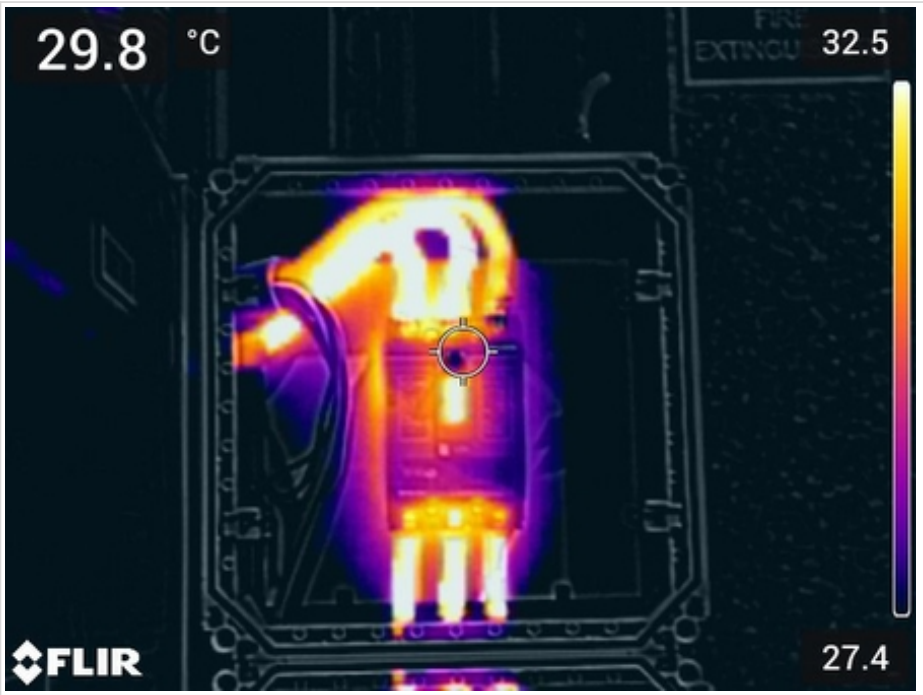
Switchboard Inspection Status	Pass
Comments and Recommendations	Exposed copper termination in cooler circuit breaker. Suggest retermination Appears to be unbalanced load on red and white phase
Next inspection Due	Feb 2026

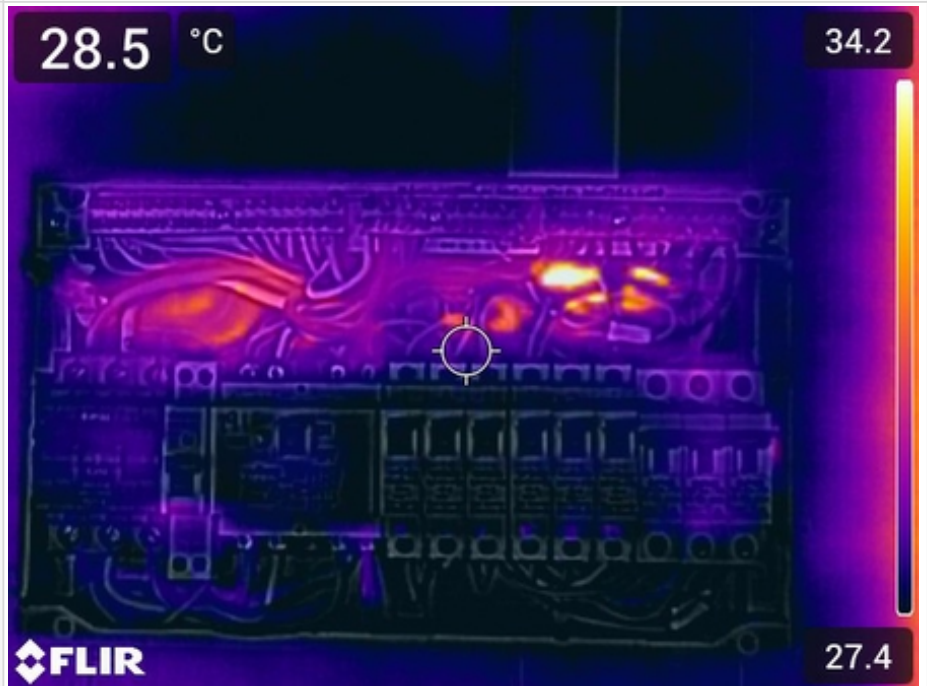
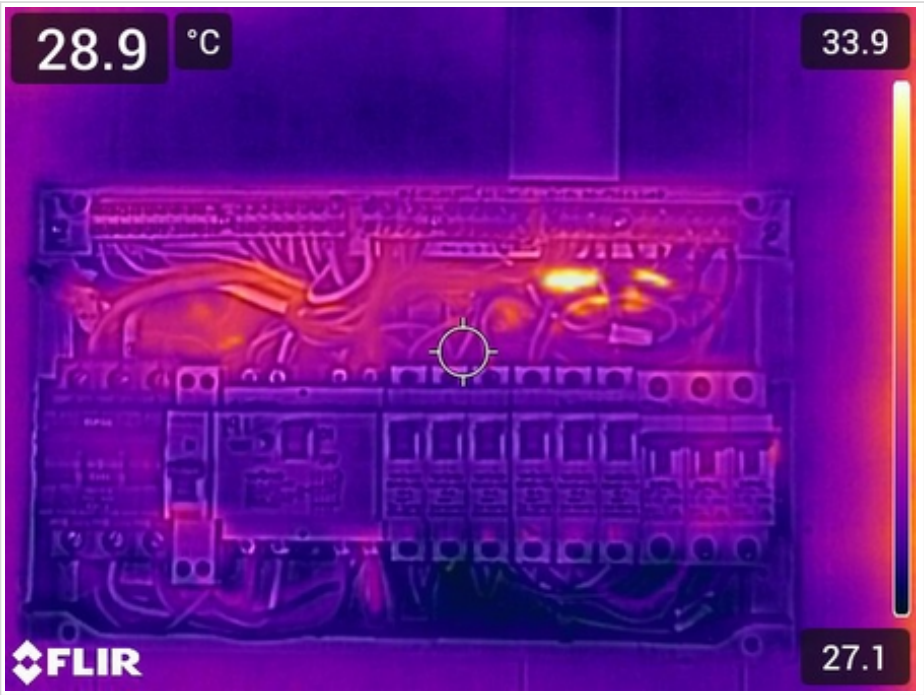
Switchboard Inspection Status	Pass
Comments and Recommendations	SWB labels remarked
Next inspection Due	Feb 2026
